Inspection Report

Mine Name: Cameron #1 and TME AR Lecy

Permit number: S0470036 and  
S0470088

Operator Name: TME Asphalt Ridge

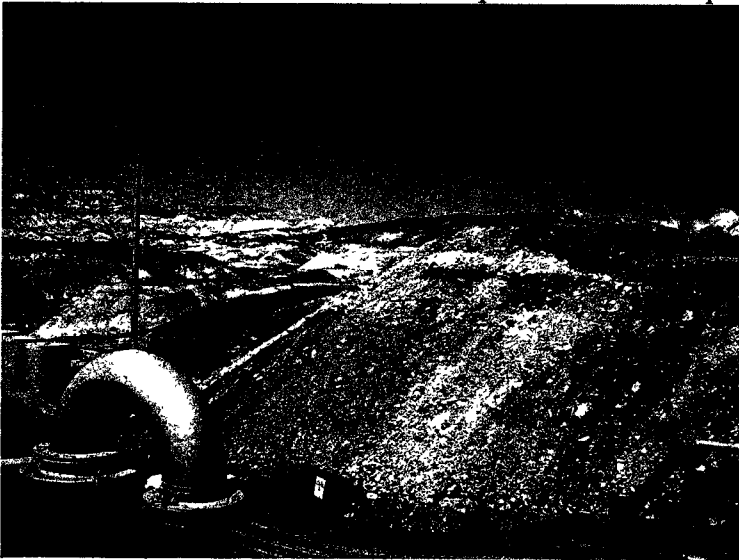
The operator has been actively mining the new TME AR Lecy Mine. Topsoil was windrowed around the edges of the pit (across the middle of Photo 2), and overburden from this mine was placed in the Cameron #1 pit (Photo 1).

**Photo 1. This is overburden from the TME AR Lecy Mine.**

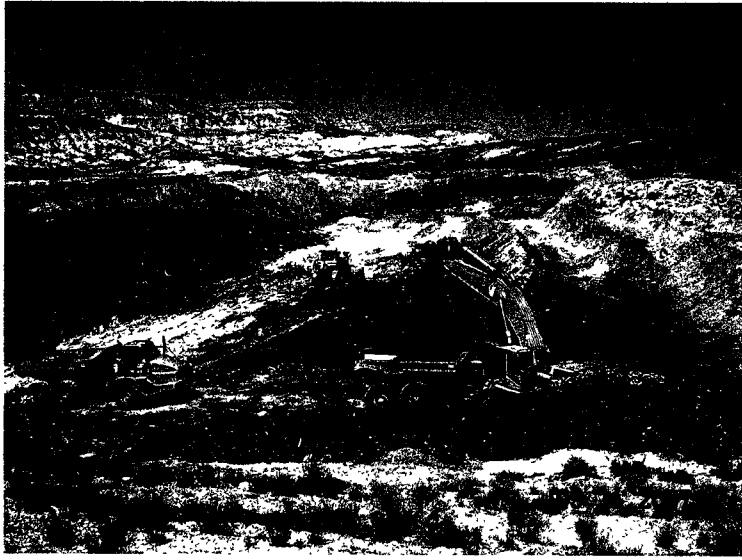
Processing equipment has been set up on the Cameron #1 Mine site with ore being brought from the TME AR Lecy Mine. An overview of the mining operation is shown in Photo 5, and the extraction equipment is shown in Photos 6-10. Stockpiled tar sand is fed through a screen after which it goes through two stages of water separation. The processed sand comes out on a conveyor (Photo 9) after which it will be taken back to the pit. The sand still contains some bitumen, and the operator hopes to refine the process so a larger percentage of this material is removed. The sand also contains somewhere around five percent water (I heard two different ranges), and they hope to start removing and recycling more of the water, probably using a centrifuge. The operator is extracting bitumen which could be processed for various products, especially as an asphalt binder or as crude oil.

I expected to see ground water in the pit (Photos 2 and 5), but there was none. Perhaps the water I have previously seen in this area is from a shallow source and has dried up during the summer.

**Photo 5.** An overview of operations in the TWM AR Lecy pit.

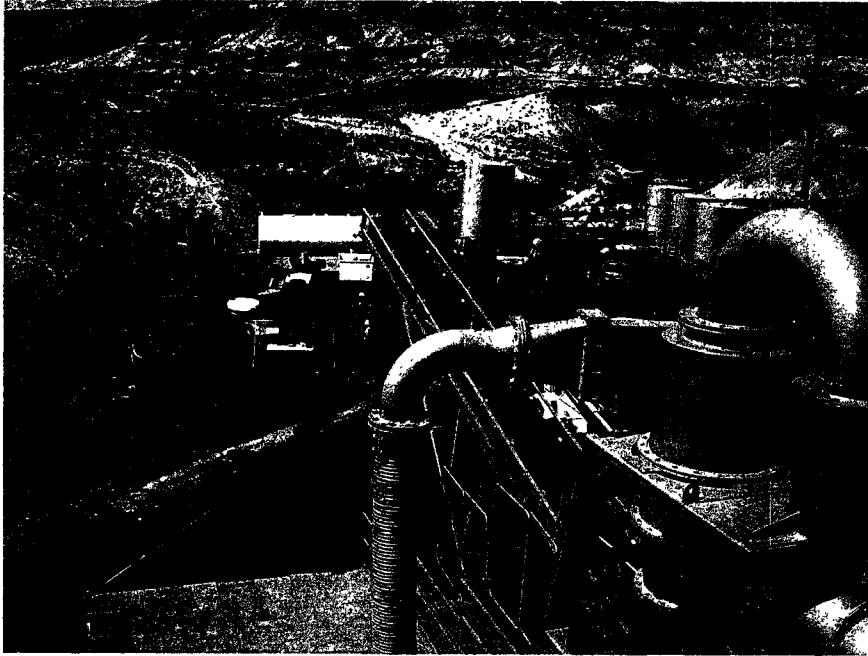
Some water was flowing from the processed sand, and there did not appear to be any effort to contain or control this water. The operator told me in an October 1 e mail that the area has been graded so water returns to a recovery point. The water is restricted by a layer of asphalt from getting into ground water.

**Photo 9.** This is the main unit of the processing equipment. Note the sand coming off the conveyor and the liquid around the sand pile.
